**National Highway
Traffic Safety
Administration**

Case Vehicle (A): 1998 Chevrolet
Type: Cavalier, 4-door sedan
Driver: 29-year-old male
CDC: 11-FDEW-2

Vehicle (B): 1991 Ford
Type: Ranger, 4x2 extended cab pickup
Driver: 18-year-old male
CDC: 99-0000-0

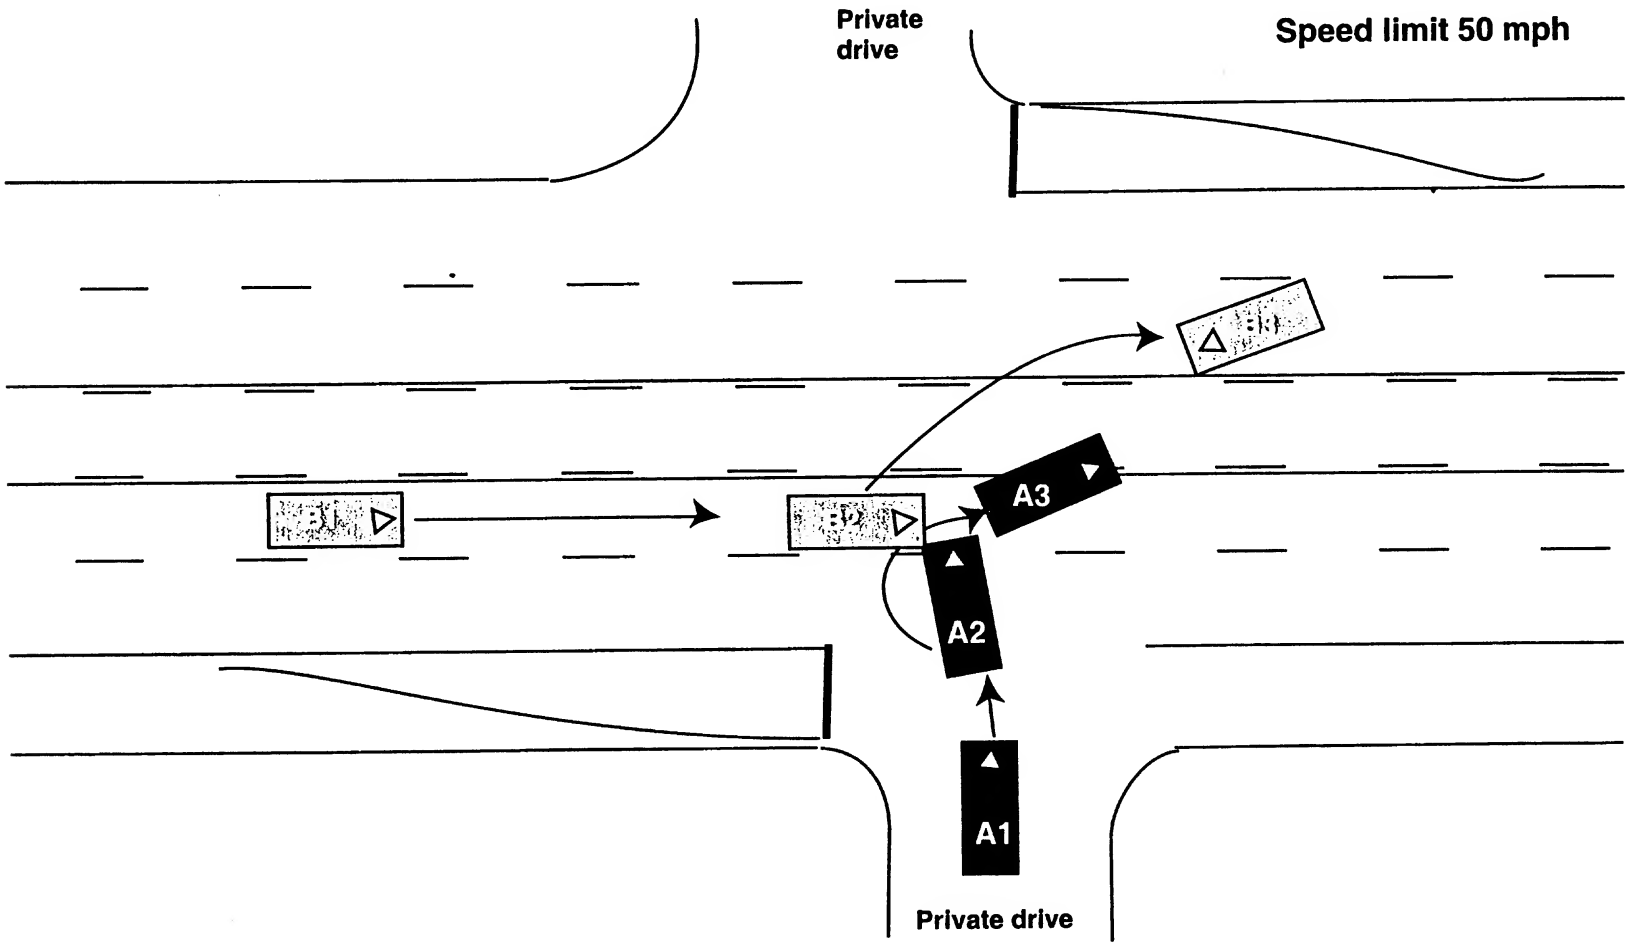
ACCIDENT SCHEMATIC

ACCIDENT DESCRIPTION: Case vehicle(A) was stopped facing north in a private drive. The driver was preparing to make a left turn onto a straight section of a 7-lane east-west roadway. Vehicle(B) was traveling in the inside eastbound lane of the east-west roadway. The driver of case vehicle(A) pulled out of the private drive to make a left turn onto the east-west roadway. The driver of vehicle(B) approached the private drive against a red light, and crossed the path of case vehicle(A). The driver of case vehicle (A) attempted to avoid a collision by braking, but was unable to keep the front of case vehicle(A) from striking the right fender of vehicle(B).

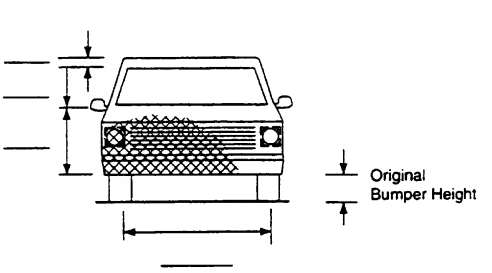
Direct damage length = 131 cm
Max crush = 30 cm

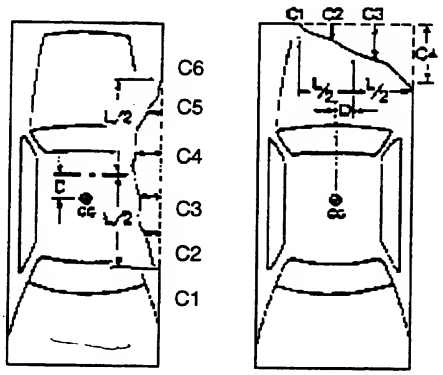
Specific Impact No.	Location of Direct Damage	Location of Field L
1	Ends (R) front bumper corner	B.C. to B.C.

DL 131

UDL 4

Specific Impact Number	Plane of Impact C-Measur.	Direct Damage Length (DDL)	Direct Damage Max Crush	Field L	C_1	C_2	C_3	C_4	C_5	C_6	±D
1	Bumper	131	C6	132	25	12	5	5	9	24	+2
	-Freespace				20 / 5	7 / 5	1 / 4	1 / 4	7 / 2	20 / 4	
	Above bumper				38	38	39	43	49	60	
	-Freespace				-30 / 8	-19 / 19	-13 / 26	-13 / 30	-19 / 30	-30 / 30	
	Ave				N/A	12	15	17	16	17	
1	5	131	030	132	005	012	015	017	017	017	+002
13	14	15 16 17	18 19 20	21 22 23	24 25 26	27 28 29	30 31 32	33 34 35	36 37 38	39 40 41	42 43 44 45
2

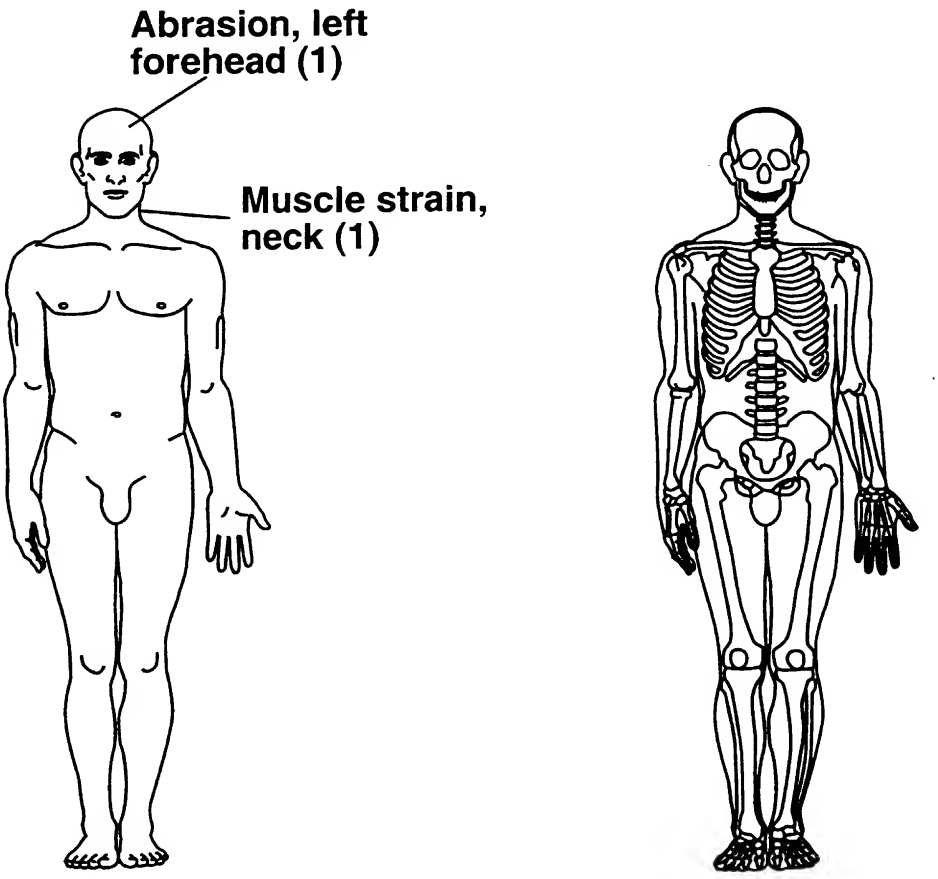
Injury Description	A.I.S.	Injury Source		
		Definite	Probable	Possible
Abrasion, left side of forehead	1		Airbag	
Muscle strain, neck	1		Impact forces	
Maximum A.I.S. Level	1			
Injury Severity Score	2
